# Pavement Maintenance Issues and Concerns

## Boeing Perspective and Aircraft Effects

Presenter's name: Michael J. Roginski, P.E.

Date: August 29- Sept.1 , 2011, Buenos  
Aires

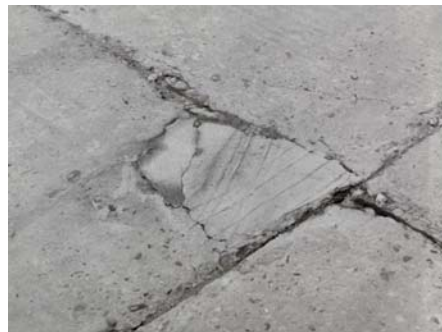
**Primary source of FOD- Pavement debris**

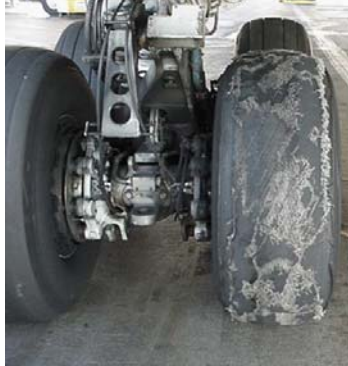
A re-treaded tire that delaminated and left debris behind- airline responsibility

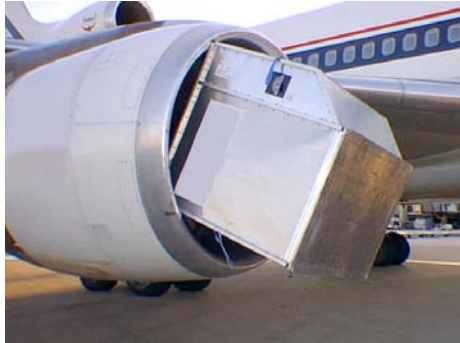
Container blown into engine of L-1011 from adjacent aircraft engine thrust

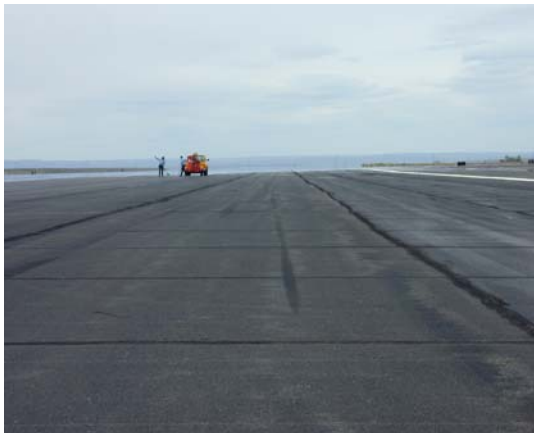
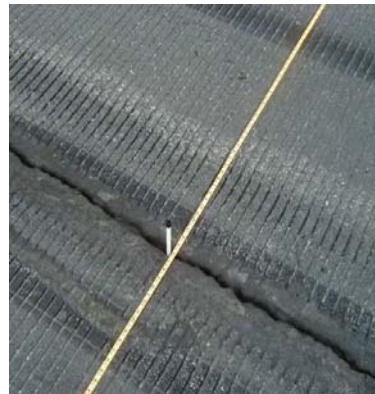
Asphalt overlay on concrete slabs had deteriorated and reflection cracks extended entire length of runway

Lack of pavement maintenance-sealing led to jet blast incident

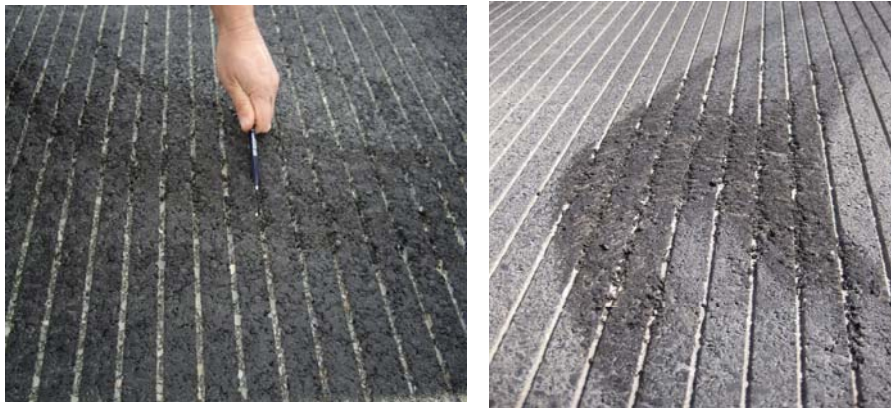
- Newly overlaid runway experienced severe FOD problems
- Groove breakdown exacerbated the problem
- Aircraft deliveries suspended until solution was found

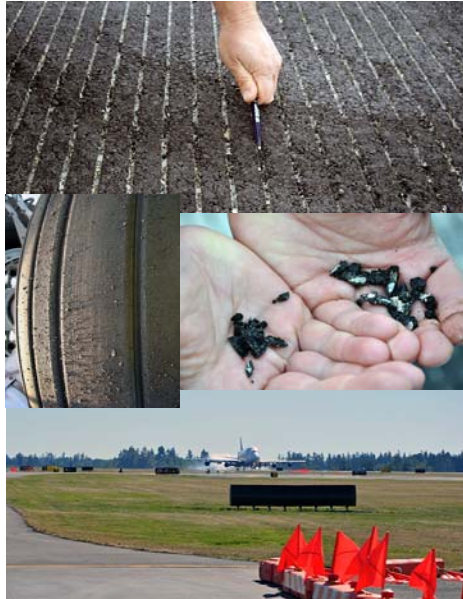
- August 21 – Airport Technology notified by Everett Delivery Center and Flight Test that aircraft were sustaining serious FOD damage
- The recently reconstructed section of the runway was the suspected source of the FOD
- Airport Technology confirmed the poor construction and identified Interim solutions which minimized disruption to numerous Boeing deliveries.
- Worked with the FAA, airport authorities and consulting engineers to identify a permanent fix.
- September 11 - Runway repair of the damaged area (over one mile long) completed. No FOD damage reported since.

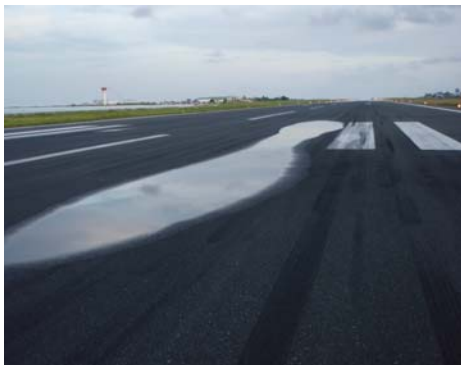
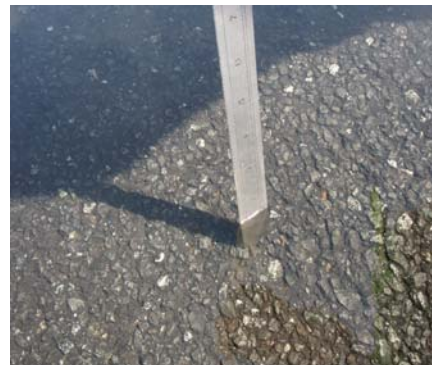
- Standing water due to improper transverse gradient suspected of causing loss of 777 junction box clamps
- Water depth in some areas as high as 2.5 cm and in high speed braking areas. Flight performance manual suggests not taking off when contamination exceeds 1.25 cm, water impingement concern.

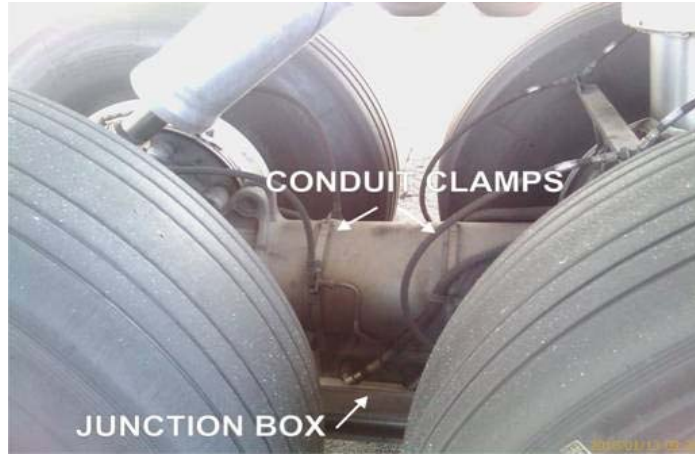
Junction box clamps on 777 truck beam susceptible to water impingement due to ponding.

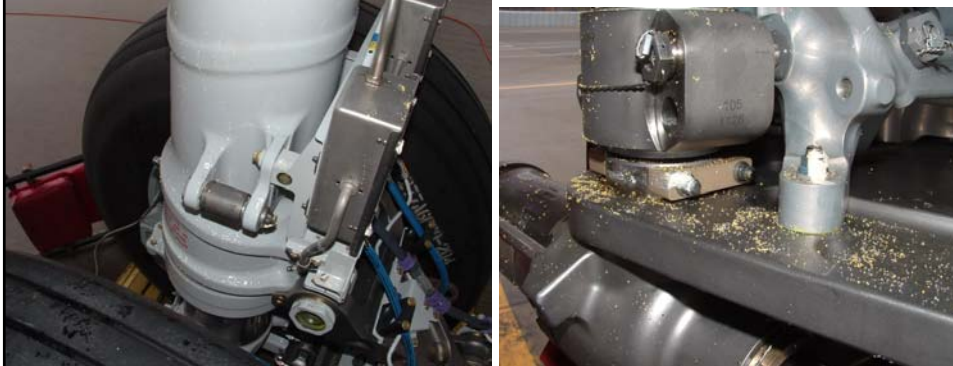
**Improper glass bead placement led to a foreign object debris (FOD) issue.**

**Damage to 10 new 737 aircraft engines cost \$50 mil US dollars.**
